# Manhole Inspection Summary

Manhole # S15S\_\_001MH

Insp Date: **6/26/08 9:43 AM**

**Location** Address: **1040 s dukeland st**

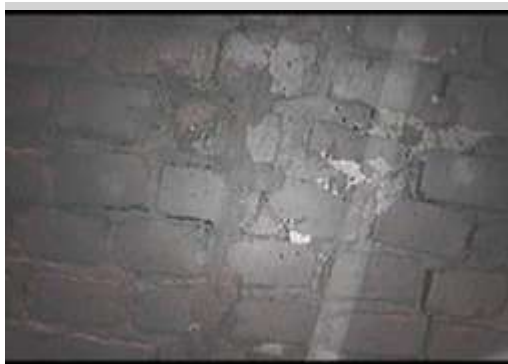
Defect 4

Infiltration: ☐ None ☐ Joint ☐ Cracks ☐ Mortar ☐ Roots ☒ **Wall**

infiltration @ corbel wall

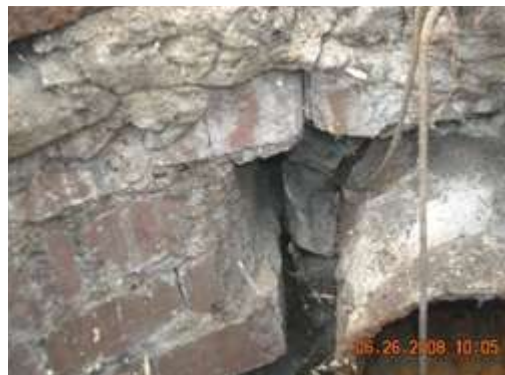
Defect 3

Condition: ☐ Sound ☐ Cracked ☐ Root Intrusion ☐ Loose Brick ☒ **Deteriorated**

deteriorated corbel bricks

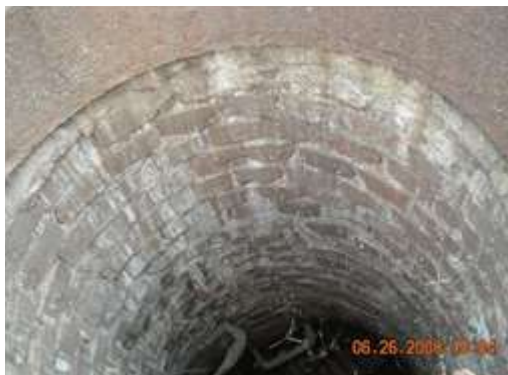
Defect 2

Infiltration: ☐ None ☒ **Joint** ☐ Cracks ☐ Mortar ☐ Roots ☐ Wall

infiltration @ corbel/frame joint

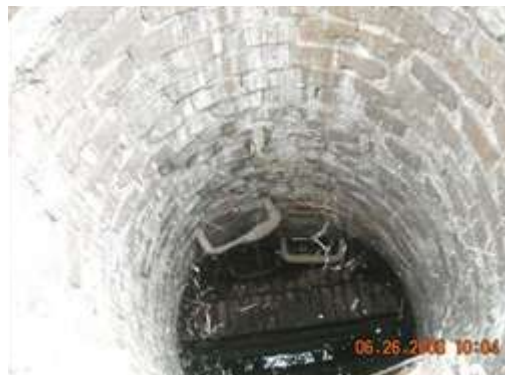
Defect 1

**Steps** Count: **3** Missing: **1** ☒ **Corroded**

corroded & missing steps

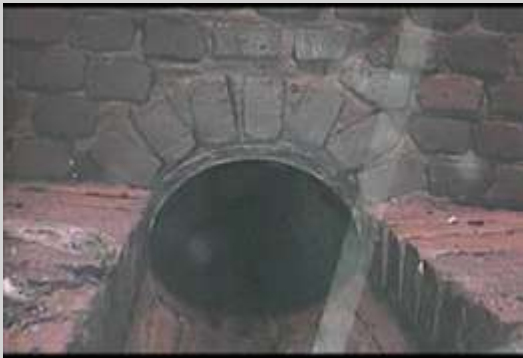
12 O'Clock Outflow

12 in. Circular Gravity Sewer  
Pipe Out @ 12 O'Clock

Pipe Height: **12** (in.) Rod and Bar (Angled)  
Pipe Material: **Clay** ☐ Pipe Lined  
Invert Depth: **9.60** (ft.) Flow Characteristics: **Slow**  
Deposits: ☒ None ☐ Mud ☐ Sludge ☐ Debris ☐ Grease  
Silt Depth: **0** (in.) Deposits Extent:  
Infiltration: **None** Pipe Seal Cond: **Sound**

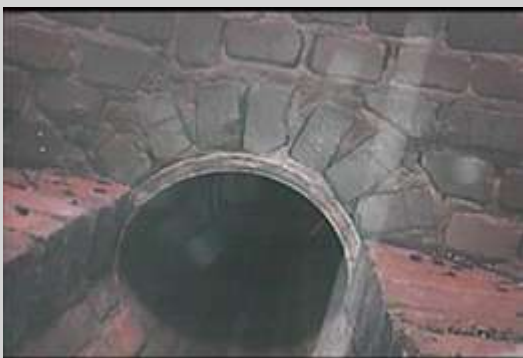
6 O'Clock Inflow

12 in. Circular Gravity Sewer  
Pipe In @ 6 O'Clock

Pipe Height: **12** (in.) Rod and Bar (Angled)  
Pipe Material: **Clay** ☐ Pipe Lined  
Invert Depth: **9.51** (ft.) Flow Characteristics: **Slow**  
Deposits: ☒ None ☐ Mud ☐ Sludge ☐ Debris ☐ Grease  
Silt Depth: **0** (in.) Deposits Extent:  
Infiltration: **None** Pipe Seal Cond: **Sound**

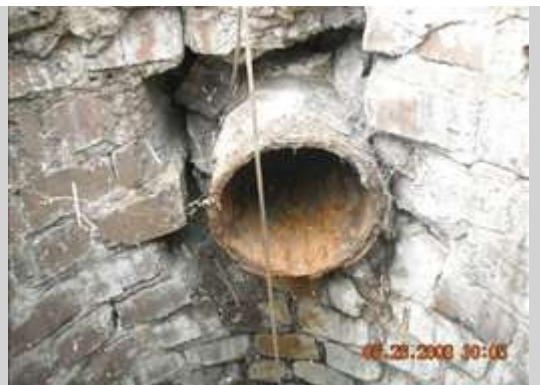
8 O'Clock Inflow

6 in. Circular Gravity Sewer  
Pipe In @ 8 O'Clock

Infiltration: **Evidence**

Pipe Seal Cond: **Broken**
